Manhole Inspection Summary

Manhole # S23I__003MH

Location Address: **1400 W Lombard St**

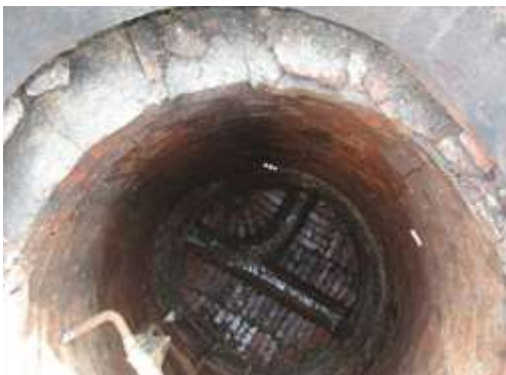
Defect 5

Condition: ☐ Sound ☐ Cracked ☐ Root Intrusion ☒ **Loose Brick** ☒ **Deteriorated**

Infiltration: ☐ None ☒ **Joint** ☐ Cracks ☒ **Mortar** ☐ Roots ☒ **Wall**

loose bricks,, missing mortar, infiltration of the chimney

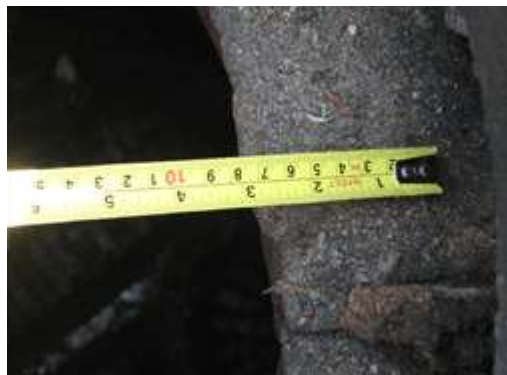
Defect 7

Offset: **4** (in.)

Condition: ☐ Sound ☐ Cracked ☒ **Leaks**

Frame Offset 4"

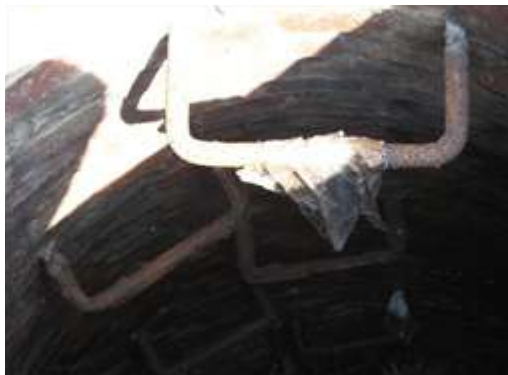
Defect 4

☒ **Evidence Of Surcharge** Depth: **10** (ft.) ☐ Active Surcharge Present

surcharge 10 ft

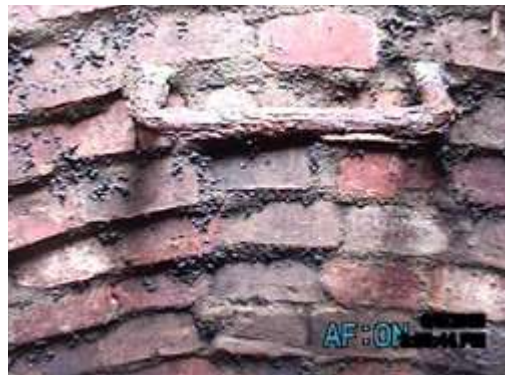
Defect 2

Count: **7** Missing: **0** ☒ **Corroded**

corroded rungs
